PRELIMINARY ASSESSMENT

Block 35 Methylene Chloride Plume Salt Lake County, Utah UTN000802657

UTAH DEPARTMENT OF ENVIRONMENTAL QUALITY
Division of Environmental Response and Remediation
Prepared by: Kim Viehweg

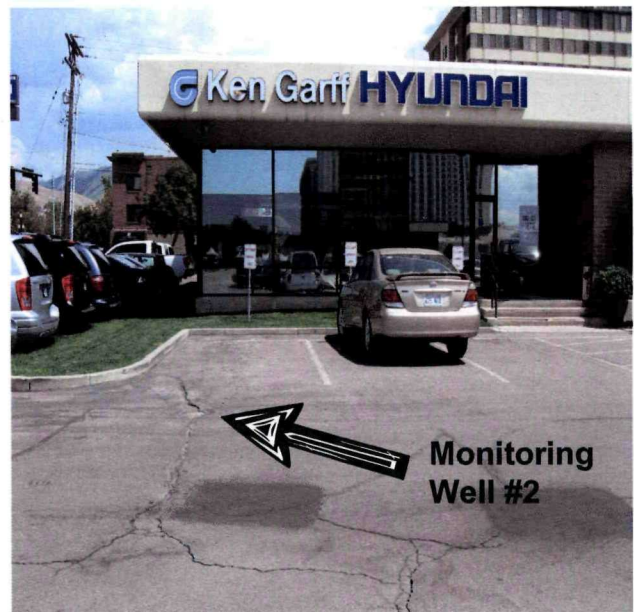
In the early 1980s, Honda Sales was located on the northeast corner of Block 35 where 500 South intersects with 200 East. Ken Garff Hyundai has since replaced the Honda Sales building and now occupies that site. In June of 1990, a 4000-gallon used oil tank was excavated from the ground approximately 75 feet southwest of the historic Honda Sales building. There were three monitoring wells installed to monitor the groundwater in connection with the UST excavation. Monitoring well #1 is west of this removed UST. A gasoline station with three USTs was located adjacent to the Honda Sales area and monitoring well #2 was installed close to this area. Monitoring well #3 is approximately 265 feet due south of monitoring well #2. During the Site visit, monitoring well #2 was located and photographed. There was an attempt to find monitoring wells #1 and #3 but they were not located.

Photo 8: Ken Garff Hyundai is located in the northeast corner of Block 35.
